Structural Controls of Hydrodynamic Anisotropy in the West Elk Mine Region, Western Colorado

ABSTRACT

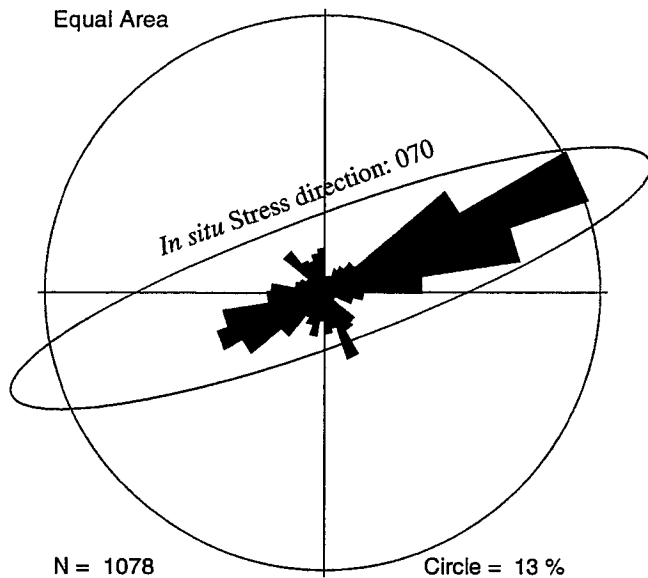
Figure 3. Rose diagram of joints measured in and near the West Elk Mine, including *in situ* stress ellipse. The stress ellipse major axis is 11.0 MPa, and the minor axis is 2.8 MPa (Maleki et al., 1996). Two separate sets of joints include a prevailing, systematic joint set and a subsidiary, non-systematic set. The strike projection is shown according to the right-hand rule, showing that the majority of the joints dip to the southeast.

Bed-normal joints that terminate into bedding planes or pre-existing fractures are found throughout the Mesa Verde Group, but they are best expressed in sandstone units and as coal cleat. Two directions are present, a prevailing set of NE-SW-oriented systematic joints (J1) and a secondary set of curvy cross-joints (J2) that abut into J1 (Figure 3).

Non-systematic, curvy cross-joints are generally oriented NW-SE (Figure 3) and abut into and connect J1. Spacing of J2 is joint controlled and variable (1–10 m) because of the mechanical influence of pre-existing J1. J2 joints are not as long or abundant as those in J1 but may play an important role in fracture permeability by interconnecting J1.

In the West Elk Mine region, the maximum *in situ* stress (σ_1) is oriented 070° – 080° (Maleki et al., 1996), which is within 10° of the mean orientation of J1 and most of the faults in the region (Figures 3 and 5). The aperture of these fractures in the mine is commonly as wide as 15 mm, with maximum widths of 17 cm in the blowout zone of the 14 HG fault. In outcrop, J1 fractures commonly have fluid alteration zones up to 20 cm thick, with up to 1.5 cm of poorly cemented sand along the fracture plane. In contrast, cross-joints, which are mostly oriented normal to σ_1 , have little to no aperture or fluid

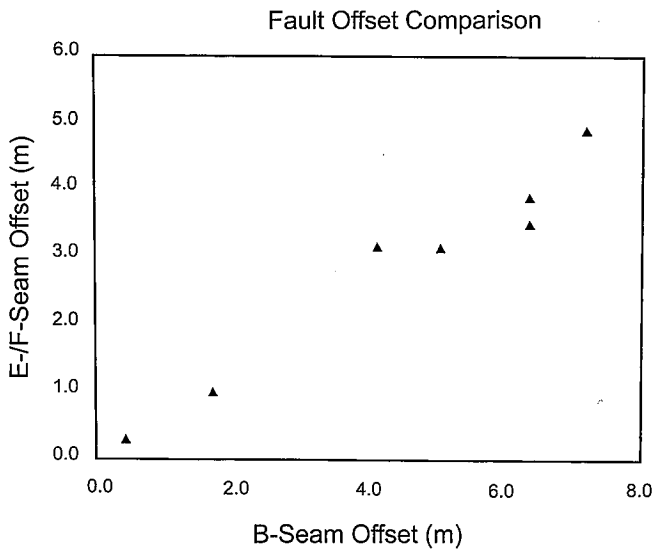
Figure 6. Vertical displacement comparison from the B-Seam to the E- and F-Seams. The dip displacement is greatest in the B-Seam and dies out up-section in all faults except the B-East Mains (BEM) Fault. These data imply that faults originated below the B-Seam, possibly in the Rollins Sandstone. The ratio of offset between the lower and upper seams is 5:3. In the BEM fault, there is no significant vertical displacement difference between the B- and E-Seams. This implies that faulting originated somewhere near the marine sandstone, between the two seams (Figure 2).

average dip displacement gradient of around 5:3 from the B- to the overlying E- and F-Seams (Figure 6). This is most significant along the 14 HG fault, which shows the greatest displacement of any fault encountered within the mine. Faults exhibiting this type of displacement

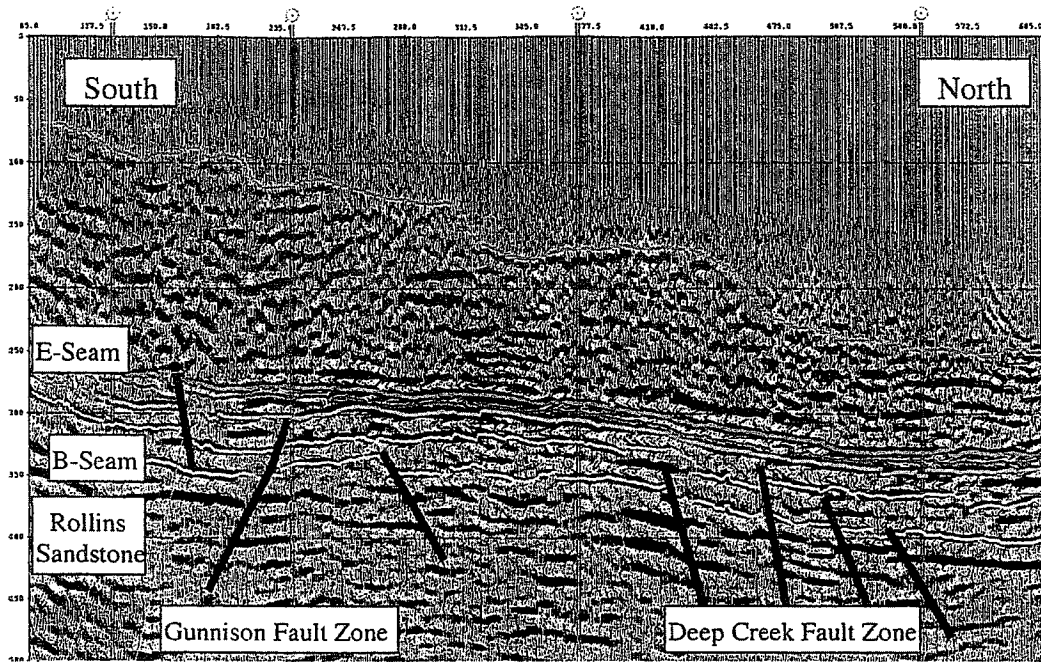
Figure 7. Deep Creek seismic line (see Figure 1 for approximate location). Note the degree of strain partitioning between stratigraphic horizons. In most cases fault displacement decreases up-dip from below the B-Seam, not offsetting the F-Seam. Some fault segments originate between the B- and F-Seams. Seismic line provided by Mountain Coal Company, LLC, and the West Elk Mine.

Measurements from seismic reflection data are limited by low resolution. However, the pattern of decreasing offset up-section is seen. The Deep Creek seismic line (Figure 7) does show more offset of the B-Seam than those higher in the section.

1:300–1:1,000 ratio predicted from studies of other faults (Muraoka and Kamata, 1983; Rippon, 1985; and Watterson, 1986). The missing slip may be accounted for by the evidence of slip partitioning observed in low strength units. The Deep Creek seismic line also shows strain partitioning between various units as well as from fault to fault (Figure 7).

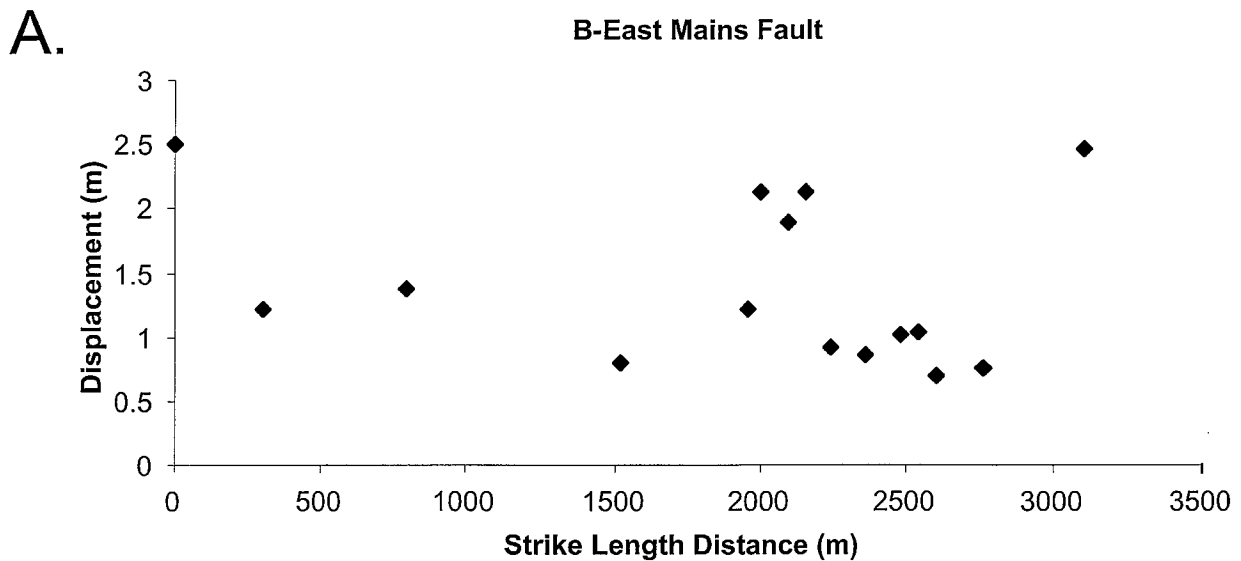
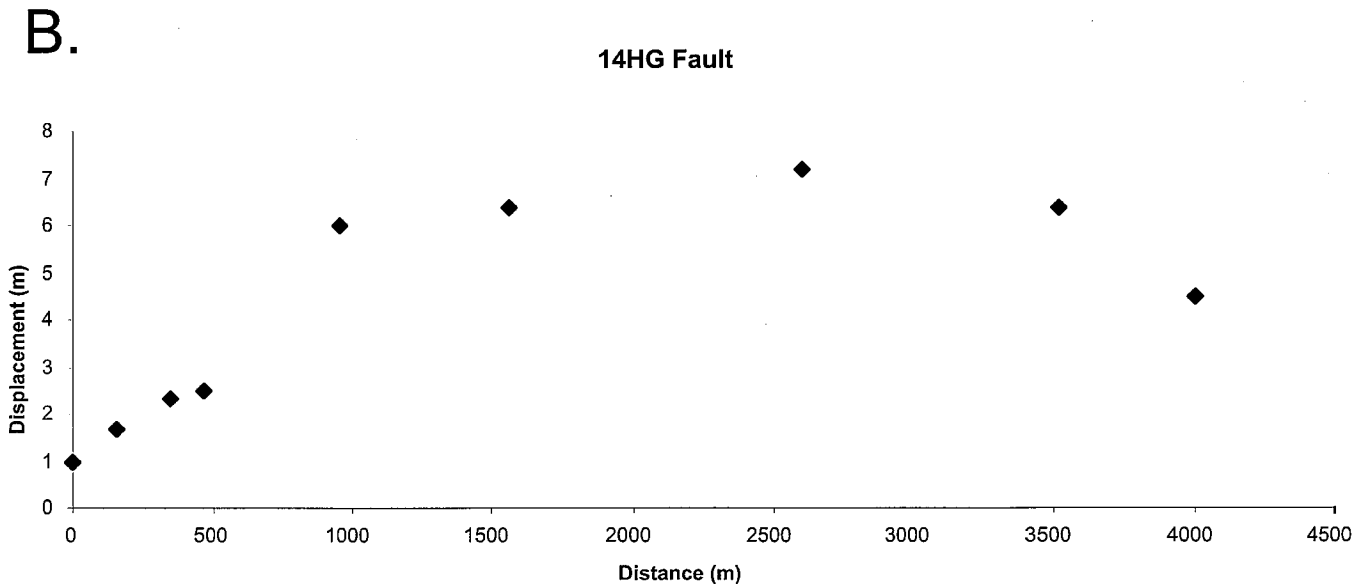
Figure 8. Plots of displacement versus strike length for (A) the B-East Mains (BEM) Fault and (B) the 14 Headgate (14 HG) Fault. The elliptical shape of the 14 HG fault versus the complex pattern of the BEM fault may be explained by the maturity of fault development, which is a function of strain localization versus partitioning.

In contrast, the displacement pattern for the 14 HG fault is characteristic of more localized deformation and produces a consistent ellipsoidal shape of strike-length versus displacement (Figure 8B). By assuming that the measured maximum displacements along the 14 HG fault occur at the half-strike-length of the fault, we estimate a total strike length of 4,500–5,000 m, which yields a displacement to strike-length ratio of 1:700–1:850. This ratio is in the under-slipped range of the
